**SLOPE STABILITY AND WATER PROBLEMS ASSOCIATED WITH SOIL
AND VEGETATION OF INNIS ARDEN**

**A.B. Adams and Rob Harrison
Soilslab**

**Ecosystems Science and Conservation
School of Forestry
University of Washington
Seattle, Washington**

November, 2001

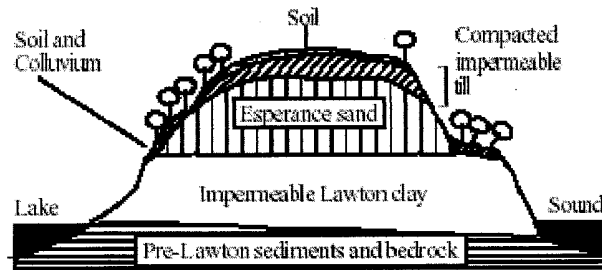
Figure 1 – Geologic Profile of Typical Central Puget Sound Coastal Areas. Lawton Clay (actually fine silt that is slippery like clay when wet) was deposited by a pro-glacial lake. Sand and compacted till were deposited by glaciers. The shelf to the right shows where sand has eroded away. Different soil types form on top of each of these geology types.

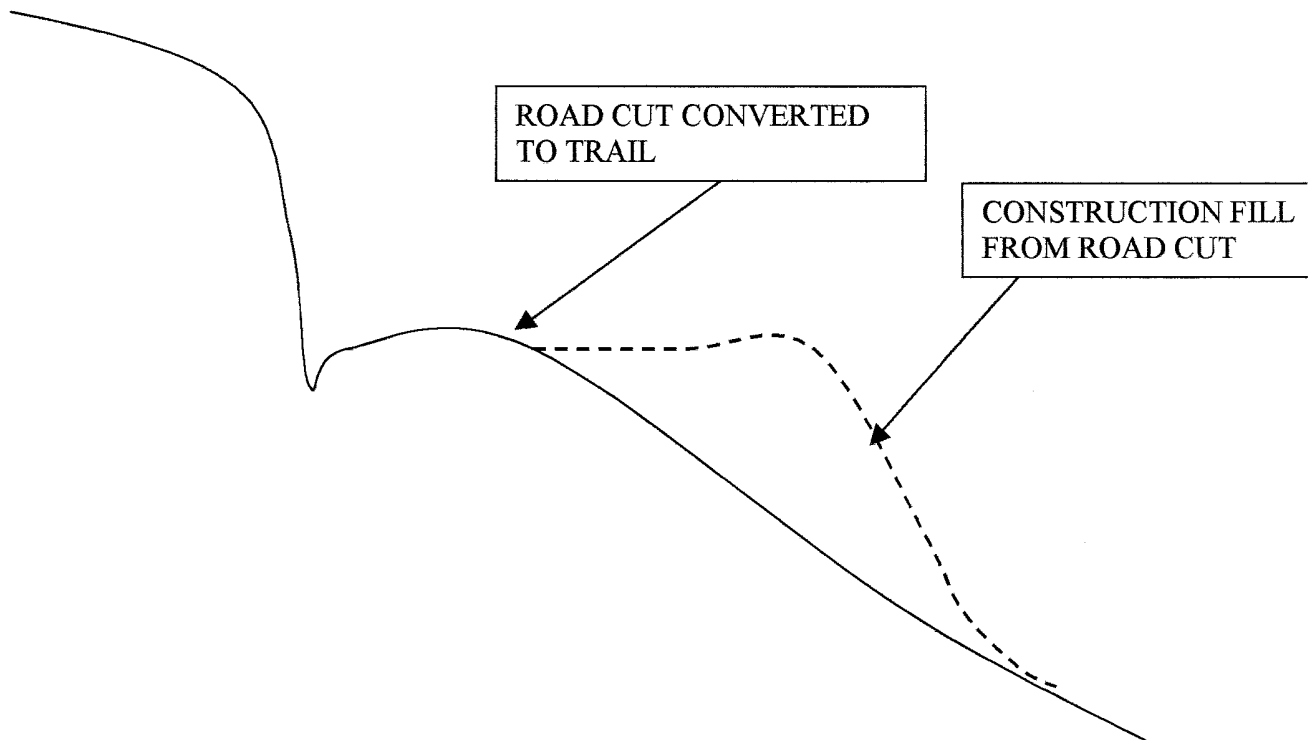
Figure 1 – Road cut showing slope grade increase due to the deposit of cut material downslope.

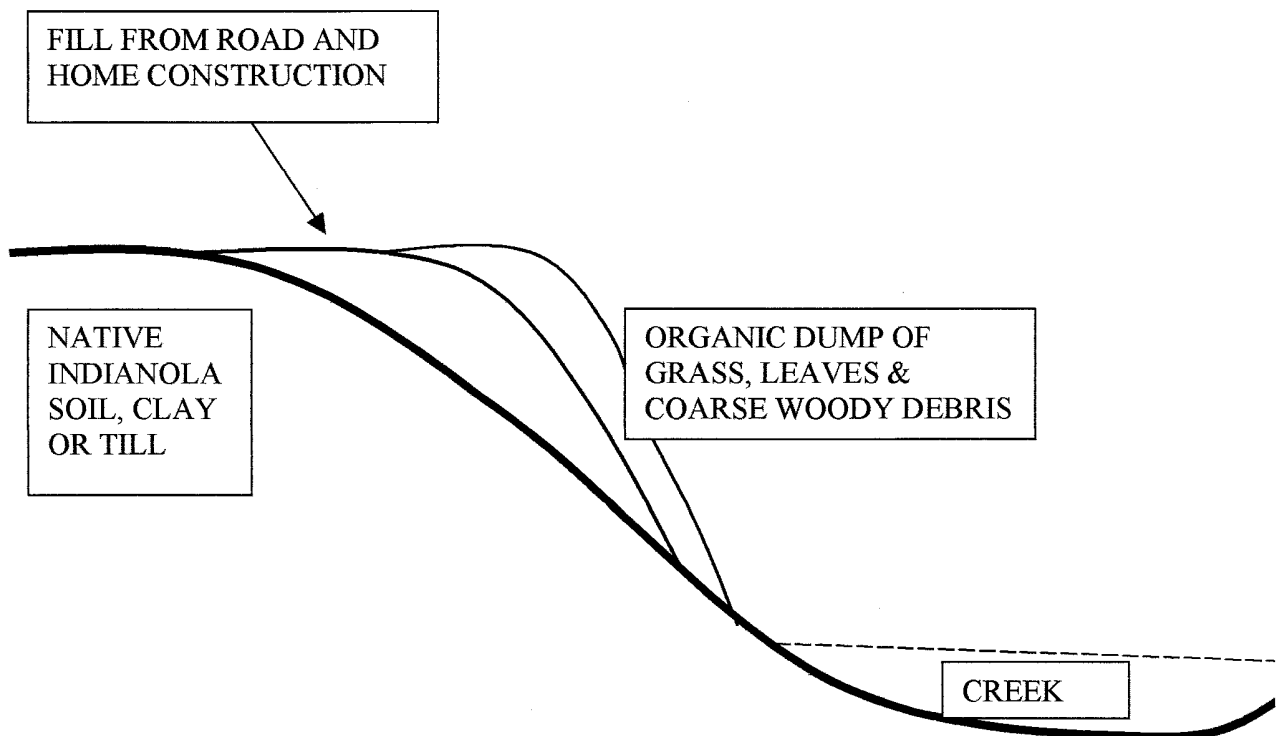
Figure 2 – Slope grade increase in watersheds associated with sequence of events. First fill material from construction (road or home) is deposited downslope. Secondly, organic debris is deposited on top of construction fill. Resulting overburden leads to debris slides.

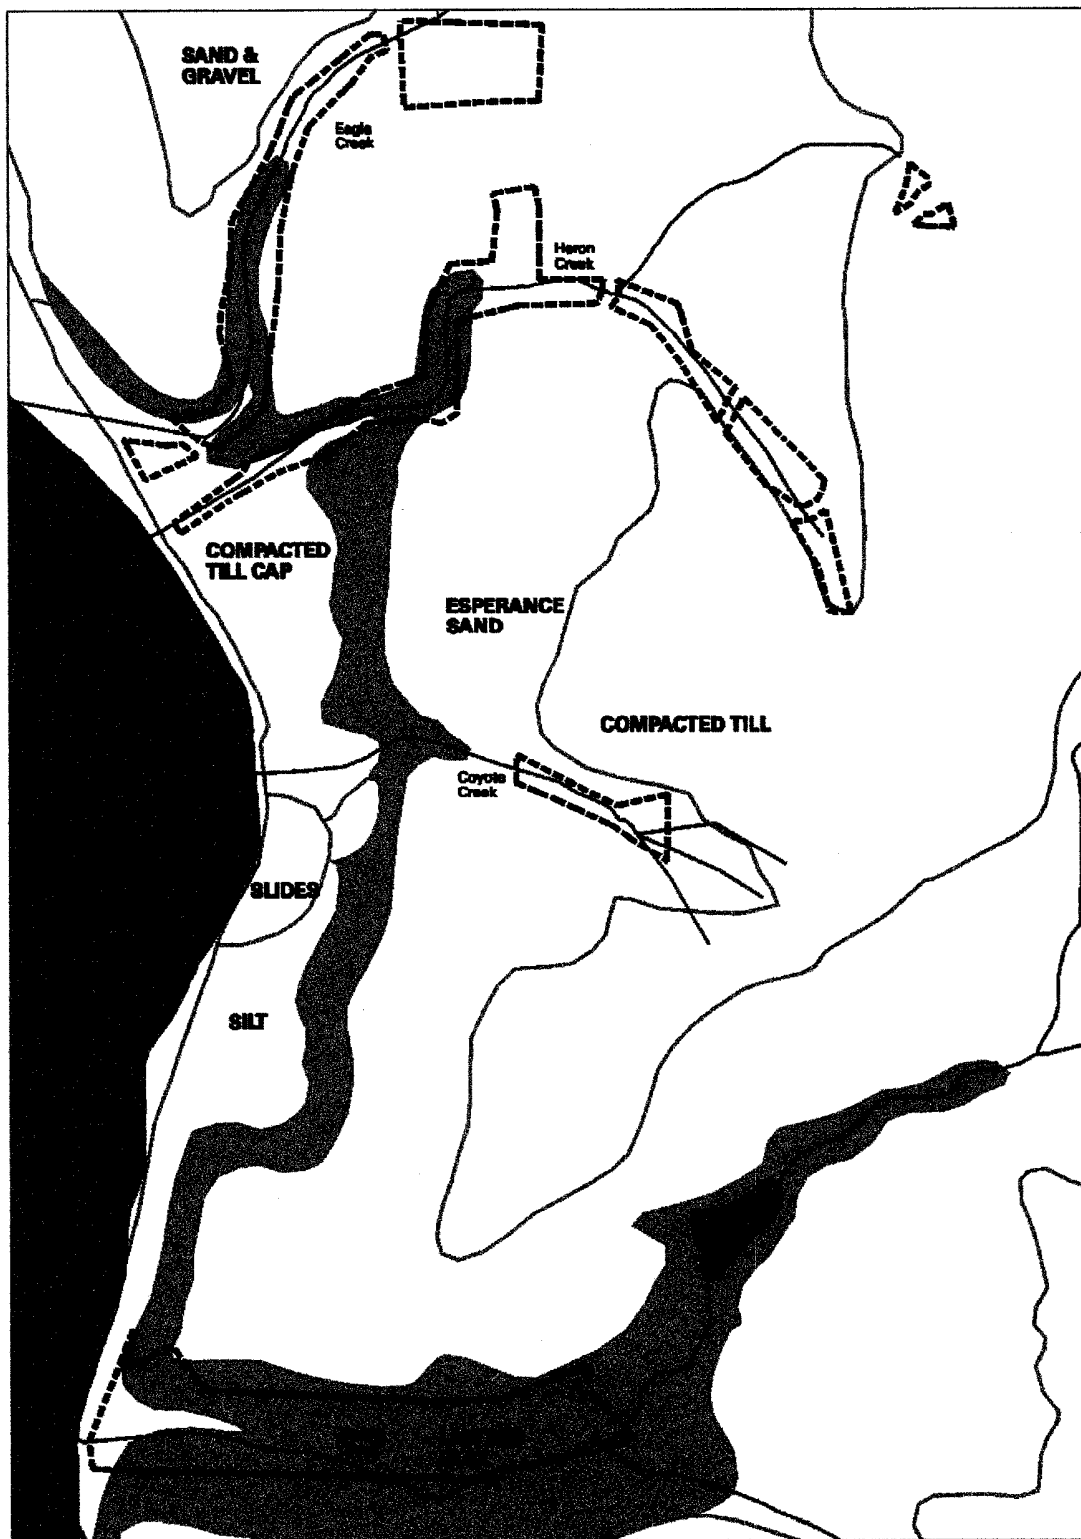
I G - INNIS ARDEN SURFICIAL GEOLOGY
 RED LINES DENOTE SURFICIAL GEOLOGIC BORDERS
 BLACK DASHED LINES - RESERVE BOUNDARIES
 BLUE LINES - STREAMS (KING COUNTY)
 Prepared for the Innis Arden
 Rich Harrison & Associates, Ltd. of Washington, Seattle
 richharrison@att.net, geol.wa

SURFICIAL GEOLOGY - Lawton Clay extends north to south and into Boogie Creek. Between Coyote & Eagle Creeks, a sand/clay complex is bordered east and west by compacted till. In the center of Innis Arden where till is not present above the Sound, sand and silt slide down a steep slope across the clay to the Sound.
